LANDSLIDES AND RELATED FEATURES

OF THE BLANDBURG, PA. QUADRANGLE

by
John S. Pomeroy
1979

OPEN FILE MAP 79-1314 (F-13)

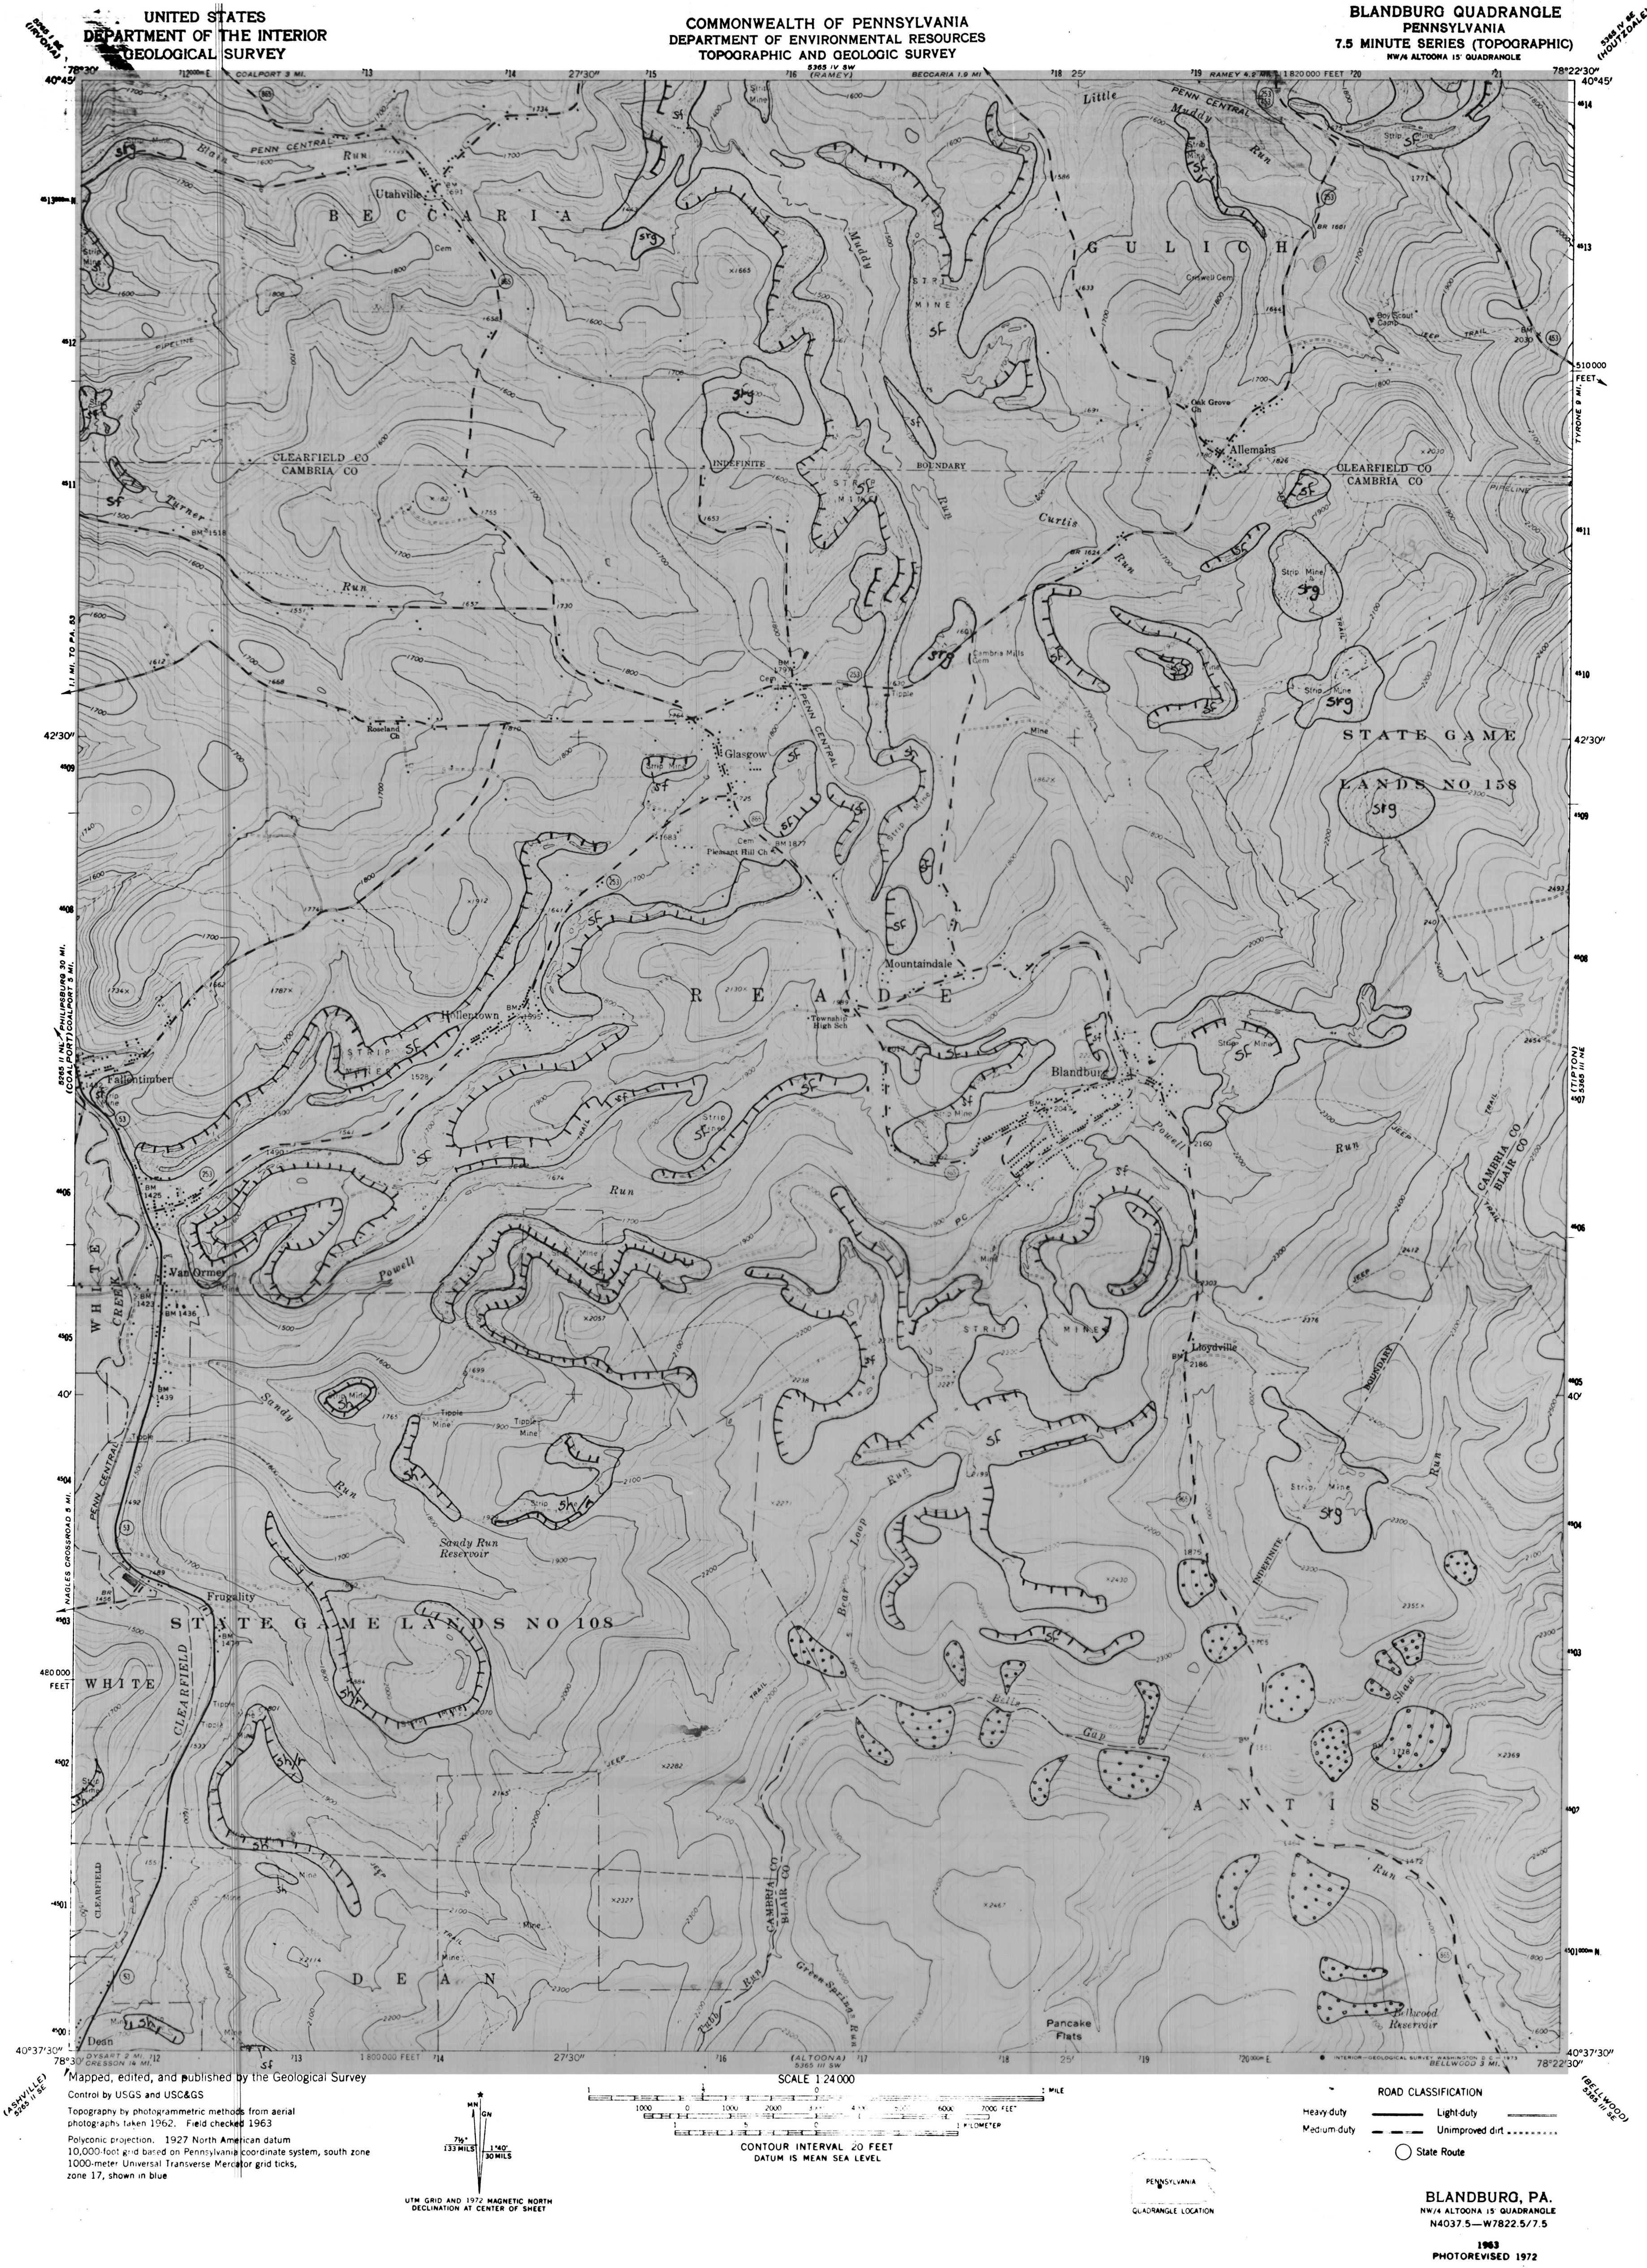
ACTIVE OR RECENTLY ACTIVE LANDSLIDE
Complex landslide composed of earthflow, debris slide, earth and rock slump. Identified from historical records, and from scars, debris and other field evidence. Ground extremely unstable; sliding accelerated by excavation, loading and changes in drainage conditions. May include areas with several active slides too small to be shown separately. Questioned where doubtful.

OLD LANDSLIDE
Area of extensive hummocky ground caused by earthflow and earth and rock slump. Lacks clear evidence of active sliding. Relatively stable in natural, undisturbed state, generally not affected by small structures properly sited in areas away from the edge of the toe; can be reactivated by extensive, rapid excavation, loading, and changes in ground water and surface water conditions. Area of old landslide probably includes recent ones not identified from field evidence or otherwise documented. Upslope boundary of landslide generally defined by modified scarp, but downslope (toe) may be gradational and not well defined. Questioned where doubtful.

COMBINATION LANDSLIDE
Area of recent and old slides in which individual slides are not identified.

COLLUVIAL SLOPE
Valley wall along major streams with slope as steep as 40° (85%); stony, clayey silt soil up to 50 ft. (15 m) thick; commonly buttressed by a terrace or bench at the toe of the slope; very susceptible to sliding by cutting of toe area, removal of terrace or bench, and overloading; slide commonly activated without apparent cause.

SCREE
Residual accumulations of coarse rock material lying on quartzite slopes of the Valley and Ridge province. Generally stable except where subjected to extreme rainfall.

COLLUVIAL SLOPES WITH LANDSLIDES
Landslides too small or obscure to map individually.

AREAS SUSCEPTIBLE TO DEBRIS FLOWS AND DEBRIS AVALANCHES
Primarily shallow, narrow ravines and chutes with accumulation of stony colluvium generally 10 ft. (3 m) or less in thickness; susceptible to rapid movement during intense rainfall. Most ravines and chutes designated show evidence of former debris flows and avalanches. Symbol & designates historical debris flow or debris avalanche.

AREAS SUSCEPTIBLE TO ROCKFALL
Steep, locally vertical, natural and man-made slopes and cliffs, 15 ft. (4.5 m) or more high; formed dominantly of sandstone, limestone, sandy shale, mudstone and claystone. Interbedded mudstone, claystone and shale weather rapidly leaving sandstone and limestone rock faces unsupported.

SOIL AND ROCK SUSCEPTIBLE TO LANDSLIDING
Soil and rock similar to that involved in landslides elsewhere in map area; primarily areas underlain by claystone, mudstone and shale associated with other rock types. Rock weathers rapidly on exposure forming clayey soil highly susceptible to sliding. Includes coves (U-shaped, shallow valleys containing thick layers of clayey soil that are very susceptible to sliding where excavation breaks continuity of slope and where overloaded by artificial fill).

AREAS LEAST PRONE TO LANDSLIDES
Map areas in which no patterns or symbols are shown; primarily valley floors, ridge tops and broad benches; modification by excavation and fill may lead to local landslides. Includes slopes where landslides are sparse.
